**Eurasian water-milfoil (*Myriophyllum spicatum*)
Late Summer Bed Mapping Survey
Teal Lake (WBIC: 2417000) – Sawyer County, Wisconsin**

Teal Lake Eurasian Water-milfoil Beds – September 2022

Endangered Resource Services, LLC
Matthew S. Berg, Research Biologist
Saint Croix Falls, Wisconsin
September 5 and 10, 2022

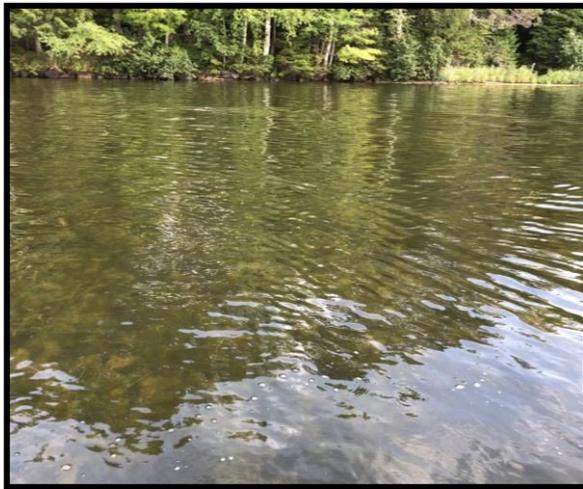
Dense canopied Eurasian Water-milfoil Bed - Teal Lake 9/10/22

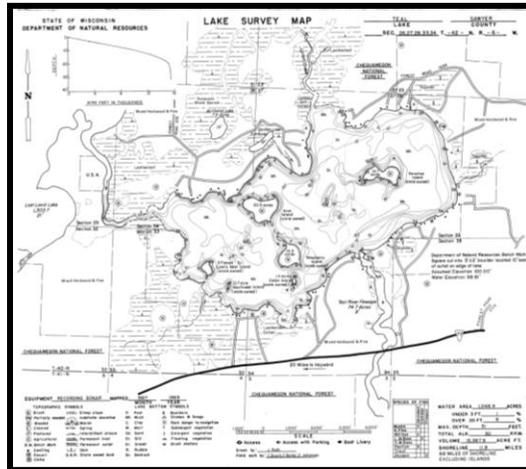
Figure 1: Teal Lake Bathymetric Map

Teal Lake (WBIC 2417000) is a 1,024-acre drainage lake in northeast Sawyer County, Wisconsin in the Town of Spider Lake (T42N R6W S26-28 and 33-34). It has a maximum depth of 31ft and an average depth of 15ft (Figure 1). The lake is eutrophic in nature, and water clarity is generally fair with summer Secchi readings ranging from 3-10ft and averaging 6.4ft from 1992-2022 (WDNR 2022). The lake's bottom substrate is variable with sand, gravel, and rock occurring along the majority of shorelines and around the lake's numerous islands and sunken islands, while sandy and organic muck dominate the deep flats and sheltered bays (Roth et al. 1969).

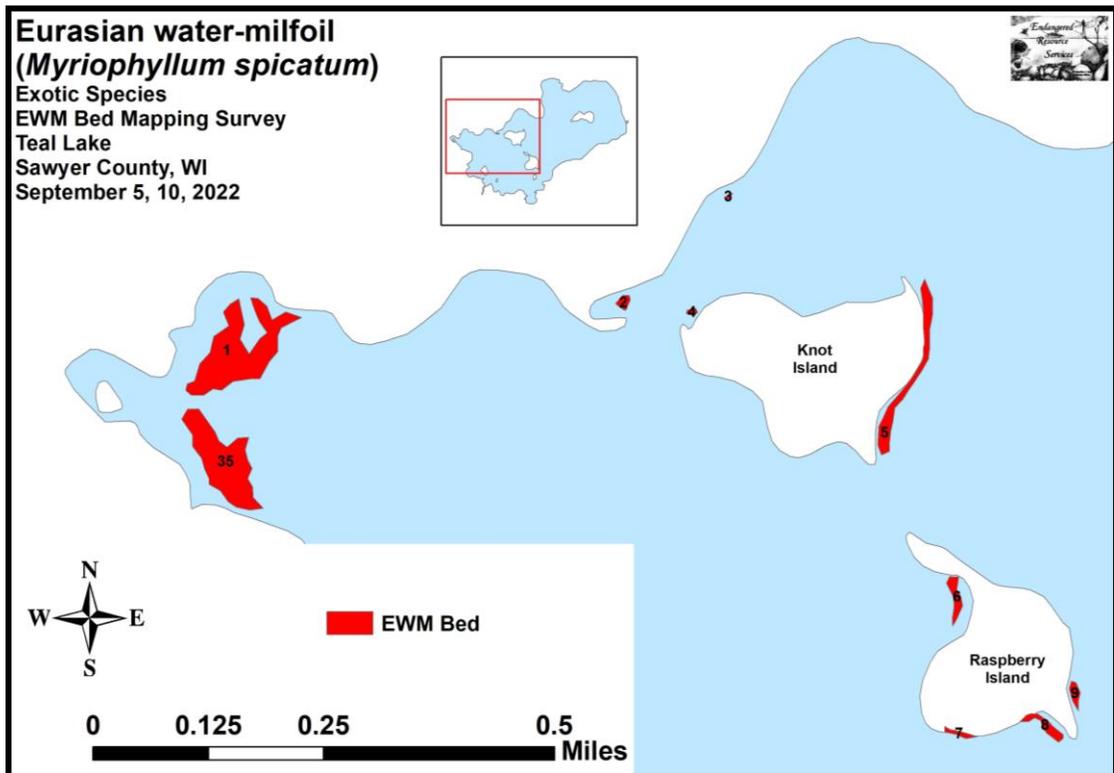
Figure 5: Beds 1-9, 35 – Northwest End

Beds 1 and 35 – These two moderate to high density beds would likely have caused severe impairment had they not been subcanopy. Boats entering Teal Lake from Lost Land Lake appear to have cut them in half, but, for management purposes, they should likely be considered one area as the beds would probably have been continuous without this constant disturbance. We noted the regular traffic and prop-clipping of plants in these beds had left the entire bay full of floating fragments, and this likely makes them a priority for any future management (Figure 5) (Appendix I).

Beds 2, 3, and 4 – These three microbeds were scattered north of the channel west of Knot Island. Only Bed 2, which occurred at the entrance of an inhabited bay, was likely to have watercraft motoring through it.

Bed 5 – Established immediately east of Knot Island, this long bed was moderately dense, but too narrow to likely cause more than minor impairment. Other than seeding fragments into northern bays, this bed is probably a non-issue from a management standpoint.

Beds 6, 7, 8, and 9 – These ribbons of EWM were scattered around Raspberry Island. Similar to Bed 5, their proximity to an uninhabited shoreline and the narrowness of the beds meant that, despite their moderate to high density, they were unlikely to cause more than minor impairment.

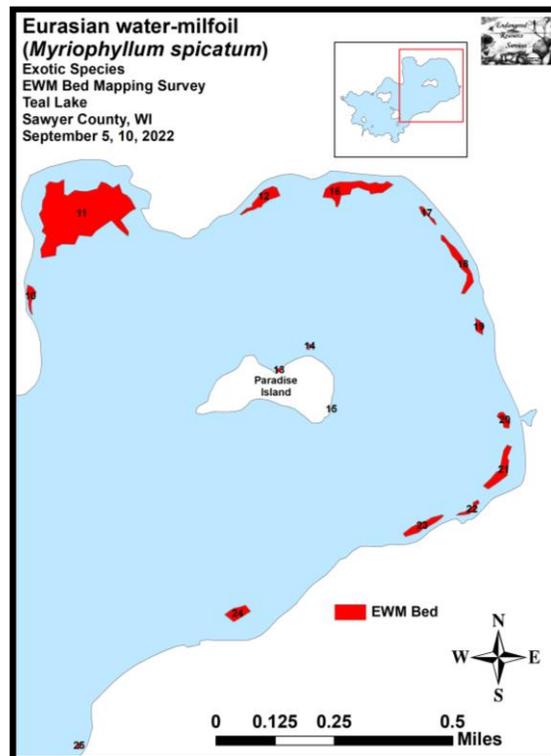
Figure 6: Beds 10-25 – Eastern Half

Bed 10 – This small moderately dense bed occurred along a highly developed shoreline. Although it was full of prop-clipped plants, the narrowness of the bed likely meant it wasn't more than a minor impairment (Figure 6) (Appendix I).

Bed 11 – Despite being the largest bed on the lake, Bed 11 was also one of the patchiest. This may mean that it is recently established, or it could be due to competition with the large number of native species in this diversity hotspot.

Bed 12 – This dense bed was established along a highly developed shoreline, and it likely would have caused severe impairment if not for its overall narrowness. Many plants were prop-clipped, and we noticed fragments occurred along the entire northeastern shoreline.

Beds 13, 14, and 15 – These three microbeds were scattered around Paradise Island's north and east shorelines. They were neither dense nor likely to cause significant impairment.

Beds 16, 17, 18, and 19 – This string of beds ringed the shoreline along the highly developed northeast bay. Each was prop-clipped, full of floating fragments, and likely at least a minor impairment. For management purposes, they should likely be considered a single bed.

Beds 20, 21, 22, and 23 – These beds ringed the southeast shoreline of the northwest bay. As with Beds 16-19, they showed extensive prop-trails and floating fragments, and they should also be considered continuous when developing a management plan for the area.

Bed 24 – We found this moderately dense bed established on a shallow area of a bar that was away from the immediate shoreline. Because it wasn't canopied, it was likely only a minor impairment.

Bed 25 – Although this microbed was established along a developed shoreline, it was so small that it was unlikely to cause more than a minor impairment (Figure 6). We noted that, unlike most high-density EWM beds, it was mixed with significant numbers of native pondweeds (*Potamogeton* spp.)

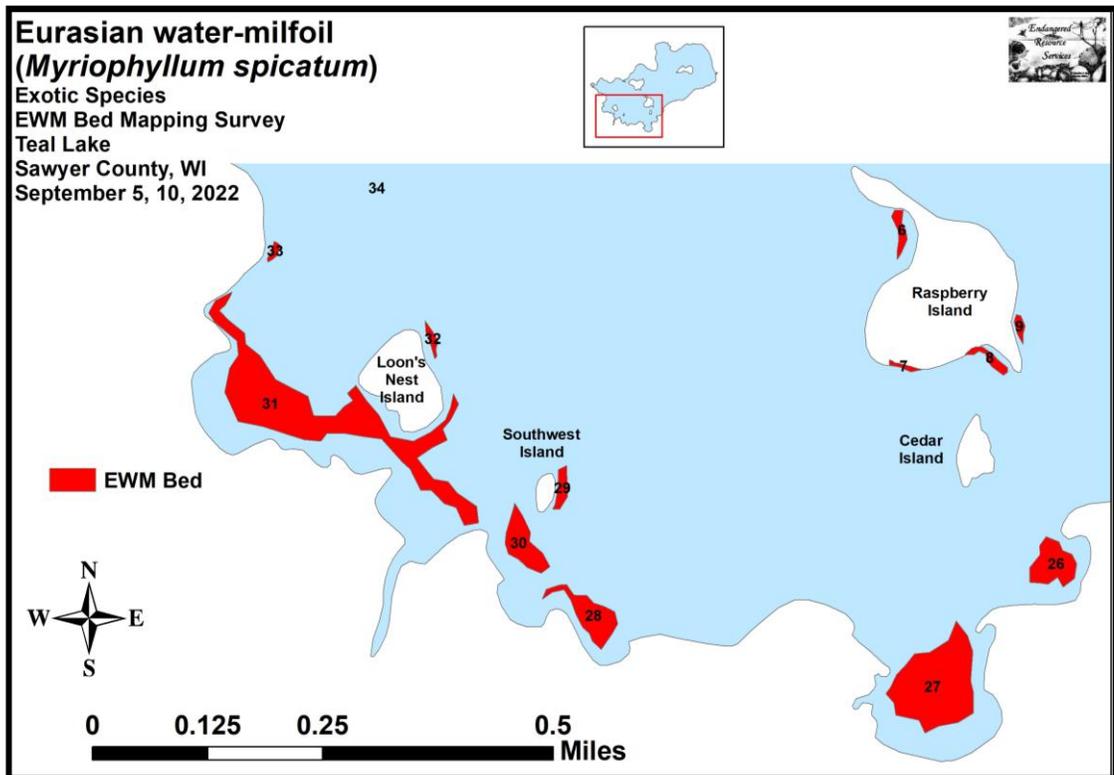
Figure 7: Beds 26-34 – Southwest End

Beds 26 and 27 – These moderate to high-density beds dominated the majority of these two developed bays (Figure 7). We observed prop-trails and floating fragments throughout each area, and it is like the impairment level, especially in Bed 26, would have been worse if it wasn't for regular in and out boat traffic chopping up the bed.

Beds 28, 30, and 31 – Collectively, the southwest bay was the worst area on the lake. EWM was dense, at or near canopy, and likely at least a moderate impairment to the area's residents. Floating fragments were everywhere, and we noted prop-trails both in front of residences and in the channels around the islands.

Beds 29 and 32 – These small beds were similar to those around the other islands. In each case, narrow littoral zones produced a ribbon-shaped bed that were unlikely to cause significant issues even though they were occasionally dense.

Bed 33 – This microbed was essentially a continuation of Bed 31. Although moderately dense, it was likely too small to be more than a minor impairment.

Bed 34 – This deepwater bed was established on an isolated rock bar. Due to its small size, it is likely a non-issue from a management standpoint.
